# Historic Westside School and Variety Early Learning Center Master Plan

December 2011

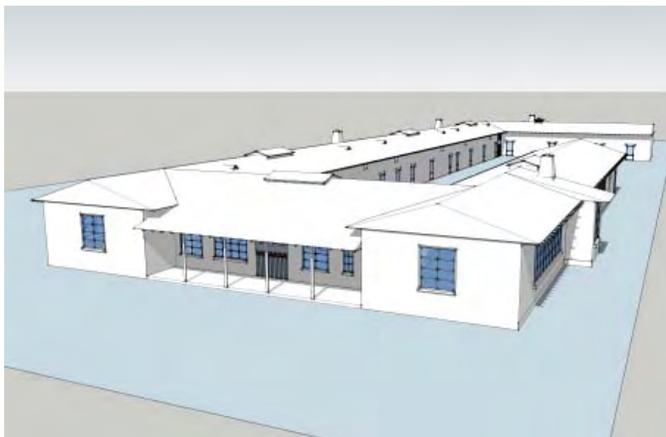
Sketch up model of Annex Building in 1948.

By 1947, the Clark County School District developed plans for the expansion of the Westside School. Designed by A.L. Worswick, the cost of the project was estimated at \$104,000. The Annex Building would house eleven additional rooms and an administration room for the school campus. The new building would accommodate grades six through eight.

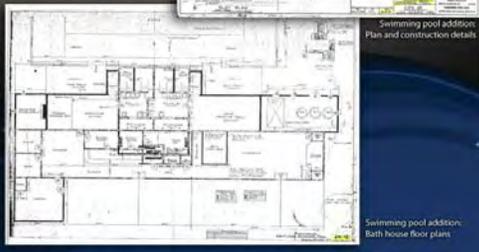
Swimming pool addition: both House floor plans.

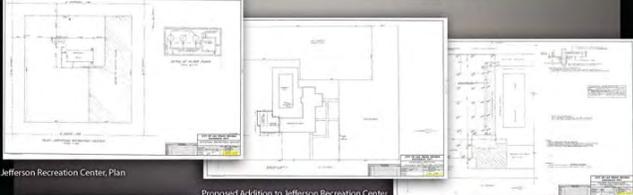
Jefferson Recreation Center, Plan  
Proposed Addition to Jefferson Recreation Center

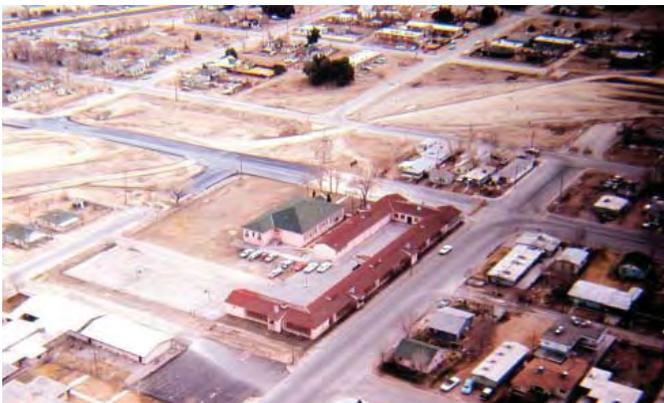
Aerial photo of property.

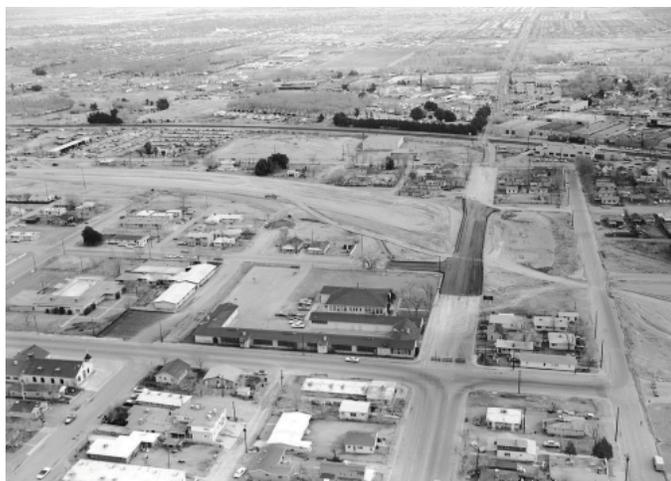
Top and bottom: two aerial views of site in 1969.

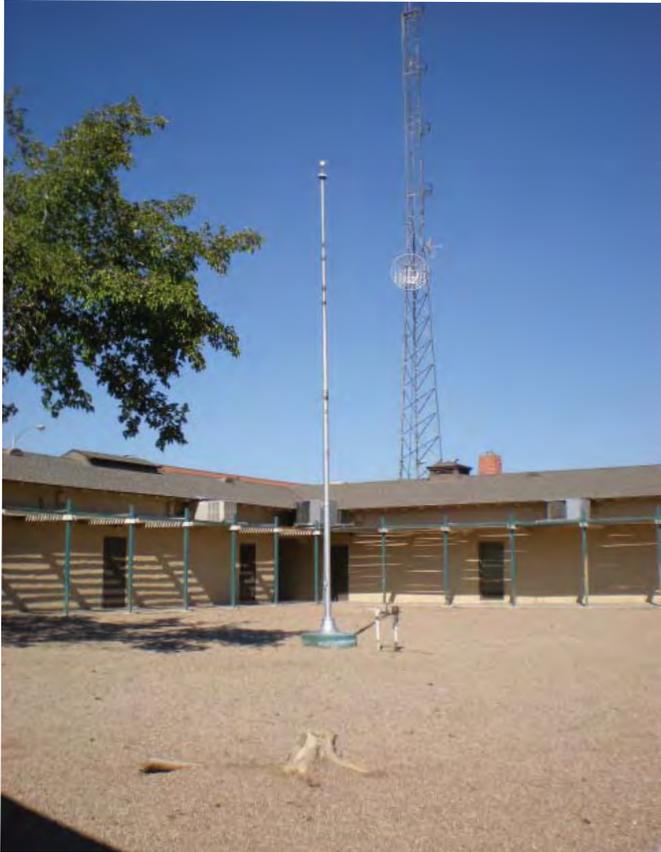
This page shows two views of the courtyard at the Annex building.

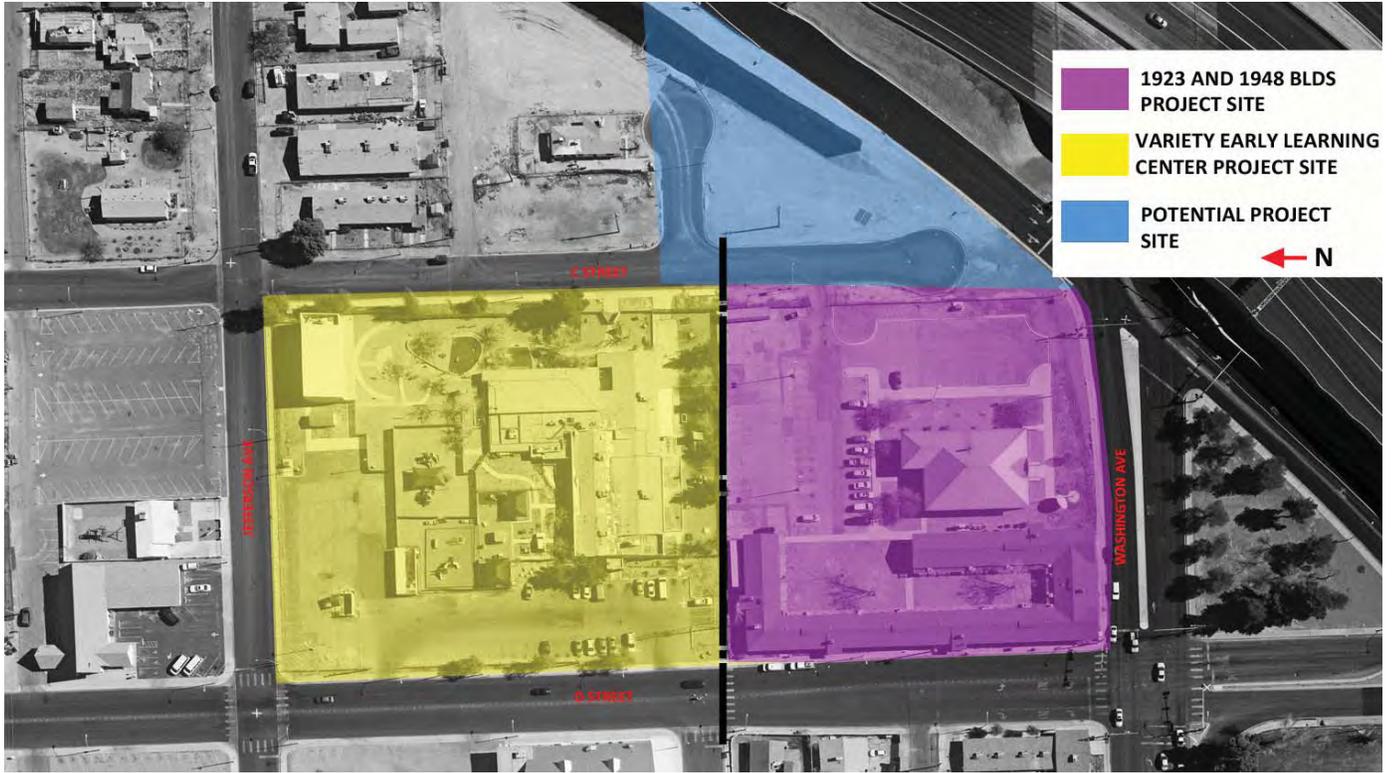
**Project Site**

The Historic Westside School and Variety Early Learning Center site will be a gateway to the greater West Las Vegas Area. The site consists of four parcels totalling 4.75 acres. An additional property just east of the site that is owned by the CLV will be used to provided additional parking.

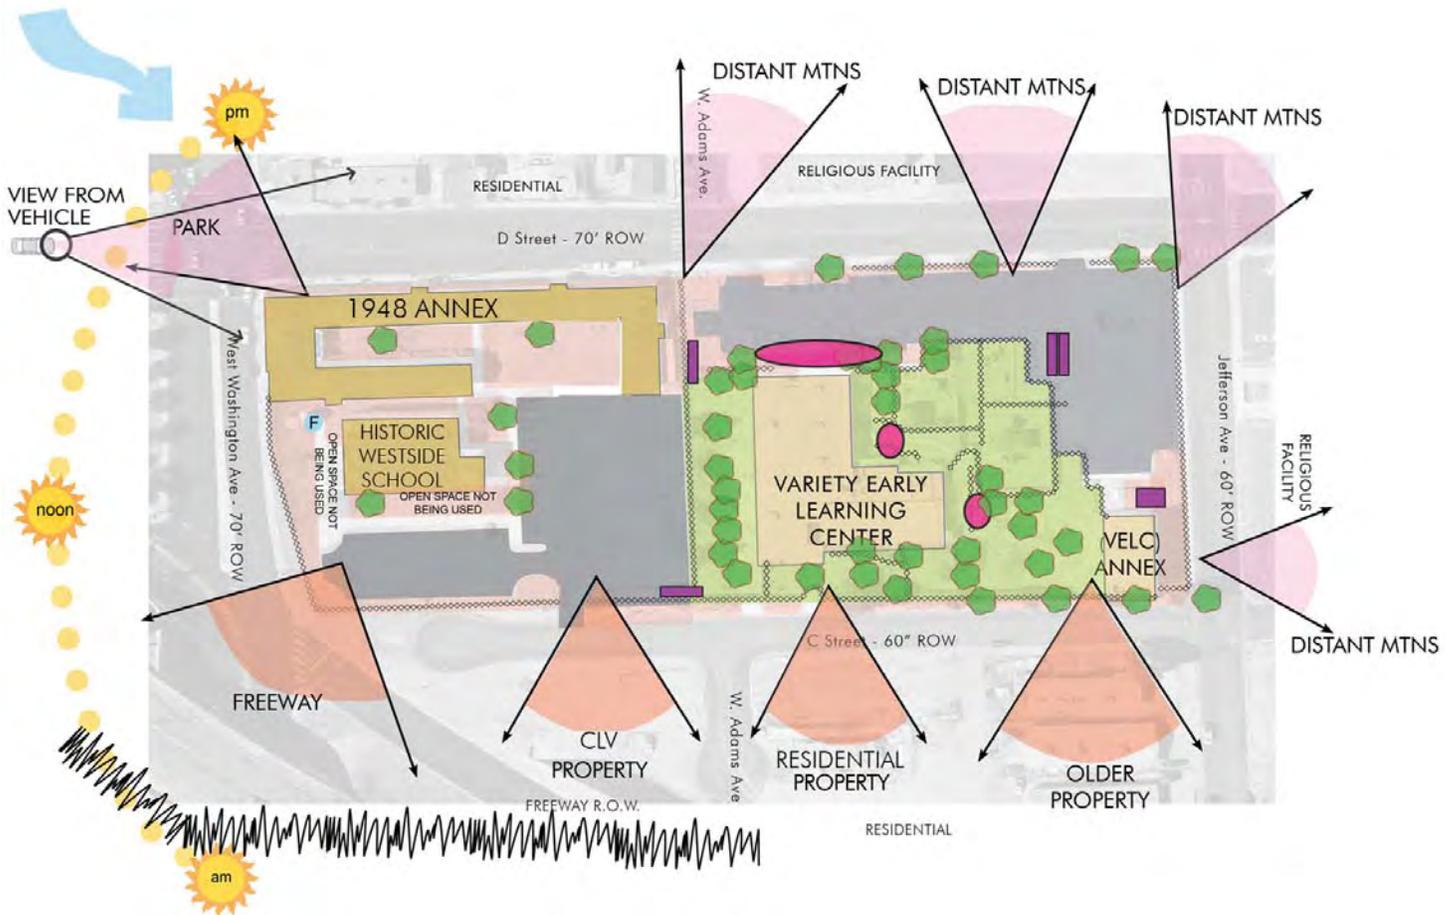
**Site Elements**

Outdoor areas generally appear worn and/or neglected. Plantings range from healthy to unhealthy. Most hardscapes are worn and showing signs of disrepair. Outdoor child activity areas are very worn and much of the play equipment is outdated, worn, and may be unsafe.

Although there is a mix of plant varieties on site, none of them are native. Rock mulch covers the planter areas. Weeds are prevalent throughout the entire site. The site plantings consist of mainly trees with the exception of the Westside School planter areas containing both drought tolerant trees and shrubs. Shrubs are also located at the VELC entrance and along a short area of the D Street streetscape. Many trees have overly exposed roots. Several trees at the Westside School have split trunks that lean hazardously.

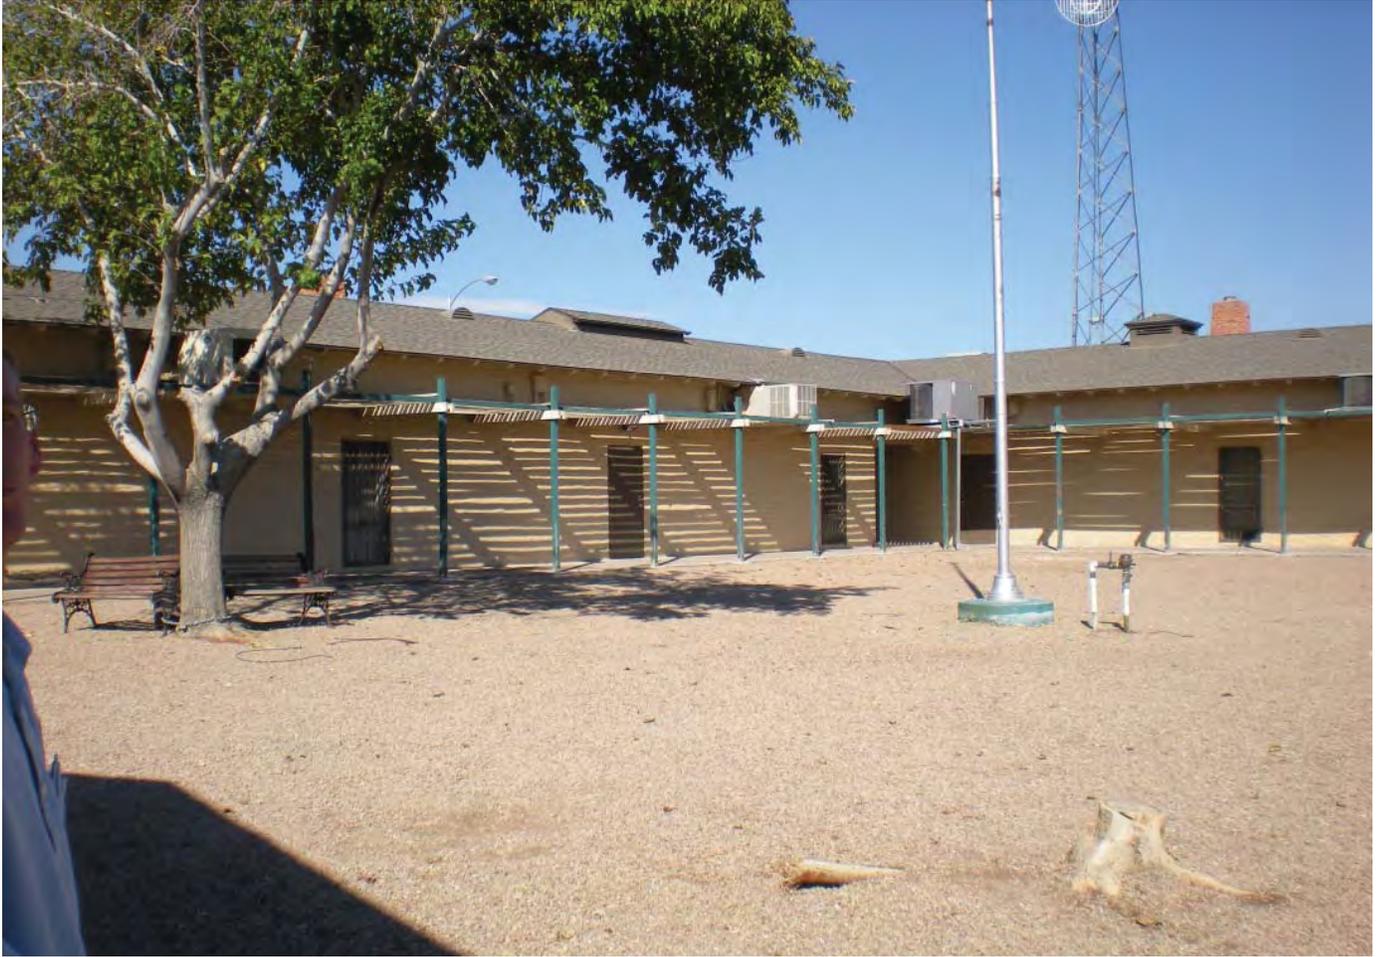
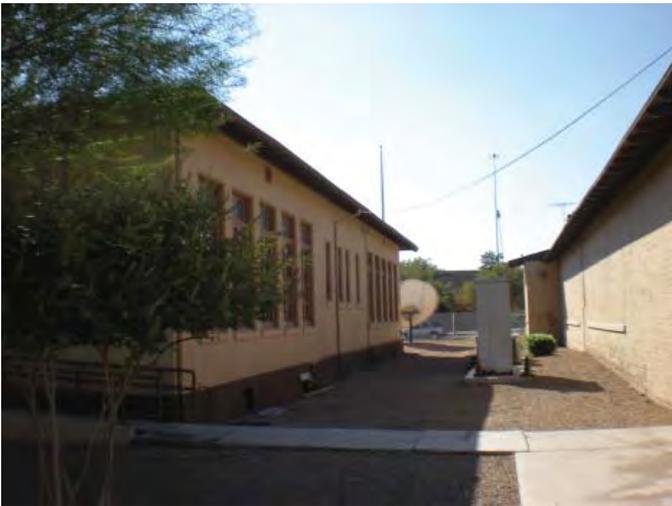
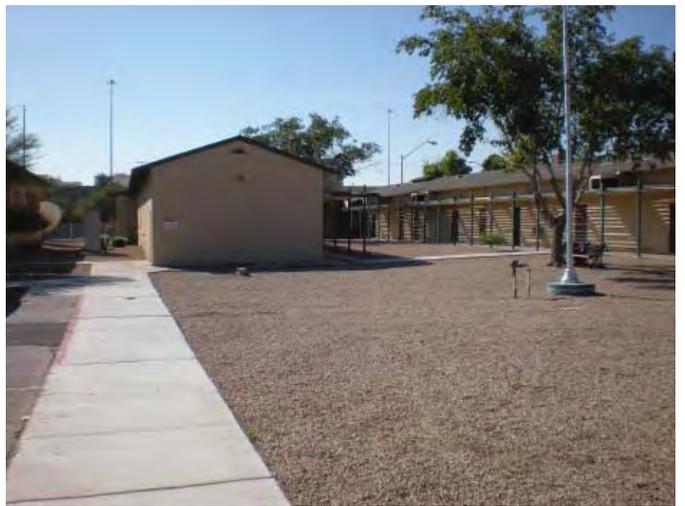
Top: Additional views of the Annex courtyard.  
Bottom right: Annex area  
Bottom left: Area between Annex and West Side School Building

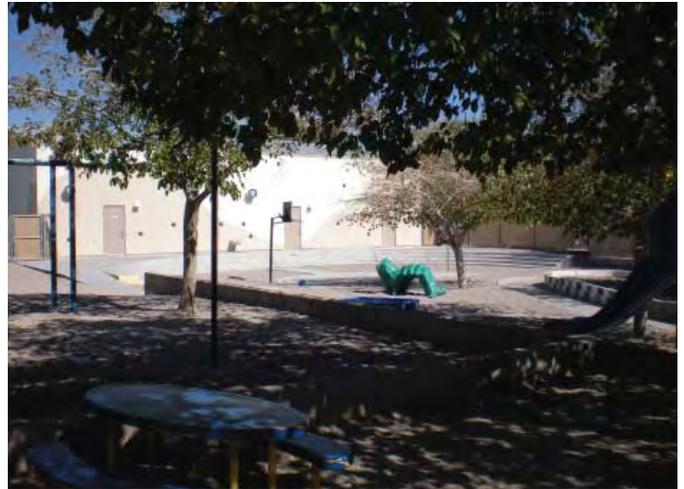
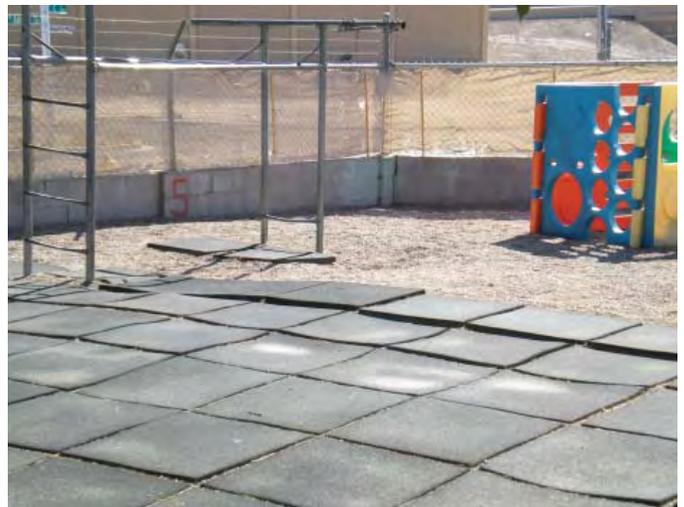
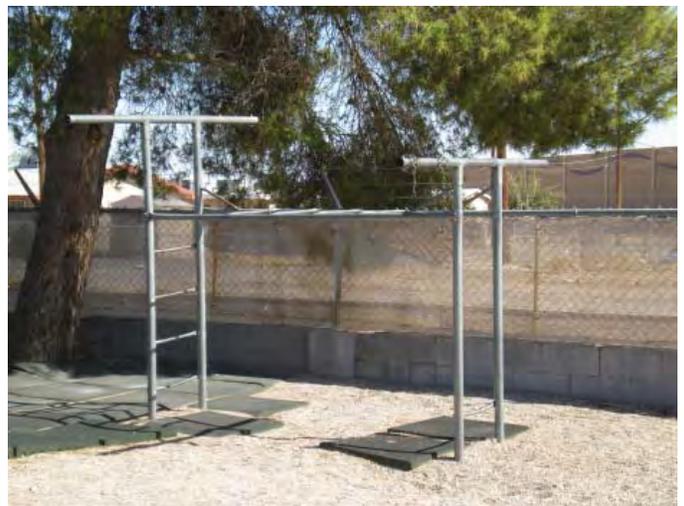
Most of the walkways show areas of wear. Spalling, heaving/lifting, and cracks are commonly observed throughout the site.

The Westside School and the VELC each have their own parking lot, although they do not connect. Asphalt within the parking lots is heavily worn with much patching, depressions and weeds growing through cracks in the pavement.

Worn site conditions at VELC site.

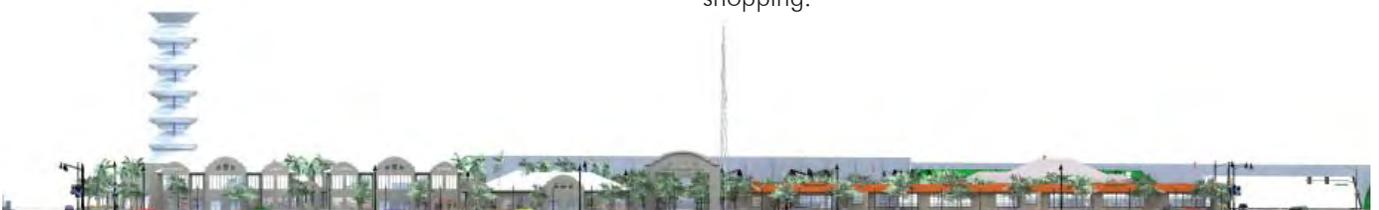
# 1960s

The HWS will provide an outdoor soundstage that supplies a venue for outdoor concerts and other events. The site and proposed buildings are designed to be in harmony with the Westside School and Annex Building. The Mission Revival style architecture is repeated in a modern context, while respecting the past. The goals of the design effort are to attract businesses to relocate and open shops in the area as well as attract tourists from the Strip and other parts of Las Vegas.

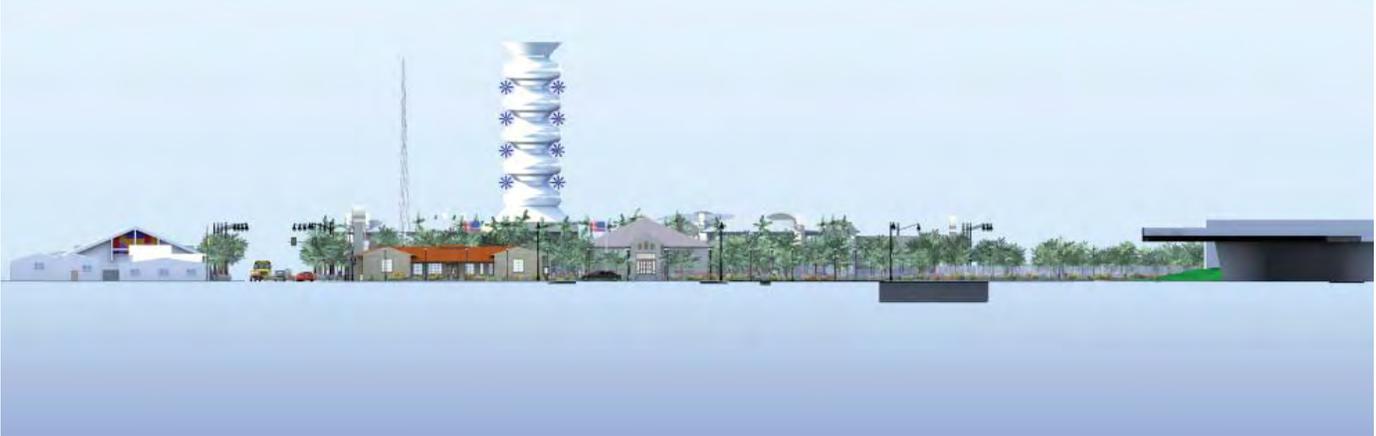
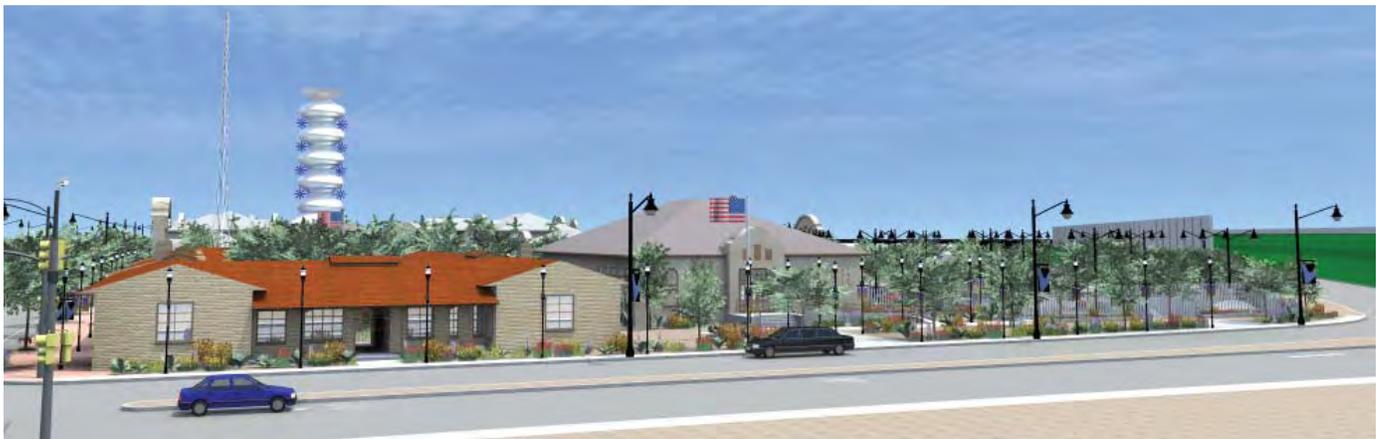
**South Elevation and Detail of Annex and Westside School**

The Annex building will house a café, retail space and offices. The courtyards will provide amenities such as landscaping, shade trees and outdoor seating for dining. The accent lights with festival banners will provide secure lighting that will promote safe gathering areas for many late night activities.

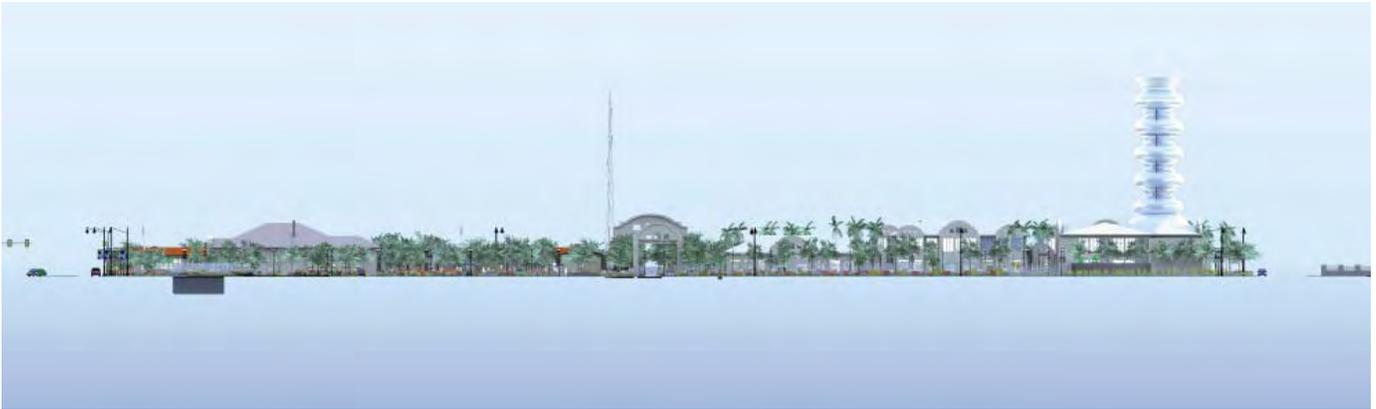
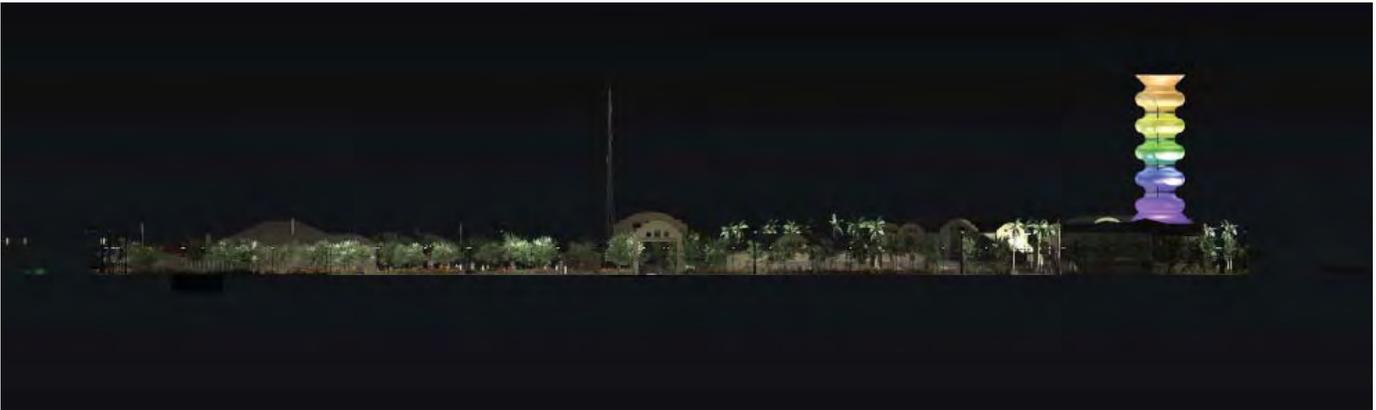
### East Day and Night Elevations

The overall site design provides a focus place for public art displays that will be relocated from the Annex building. The focal point will connect the Historic site with the new proposed Variety Early Learning Center site.

The one-way paved street will provide access from C Street to D Street. Pavers will be used to accent the driveway and provide a more natural setting that asphalt and concrete cannot achieve and will be stainable. A different color paver and texture will highlight the pedestrian crossing from the historic site to the VELC site. Pathway lights along the driveway will provide protection for pedestrians.

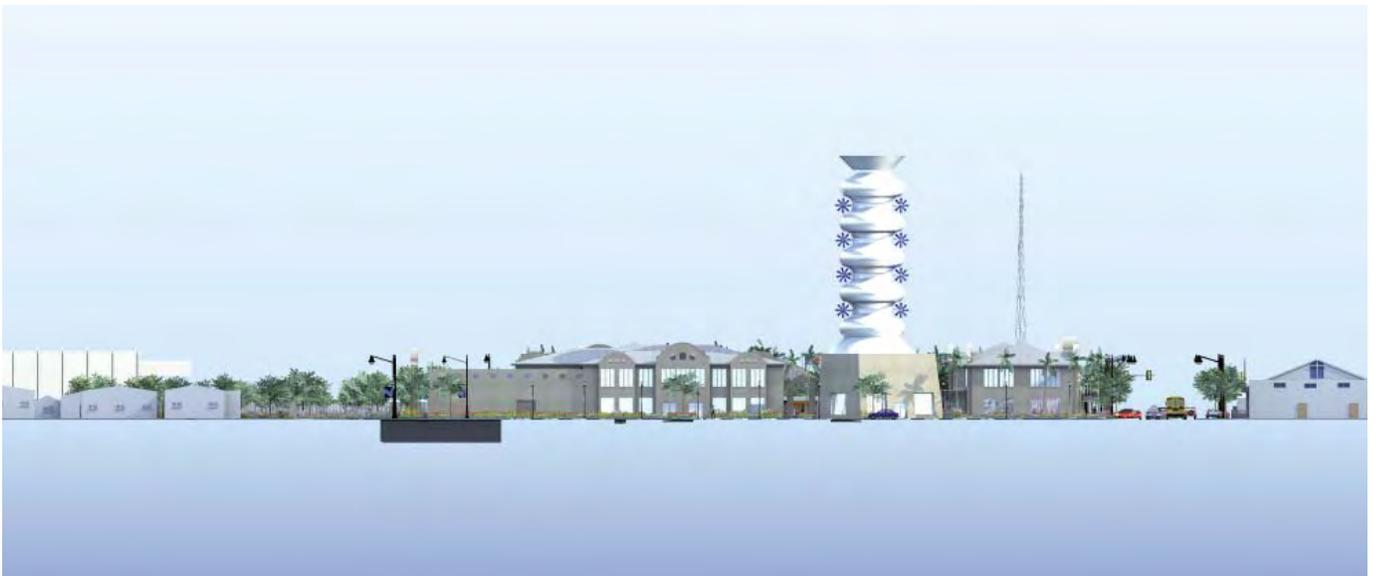
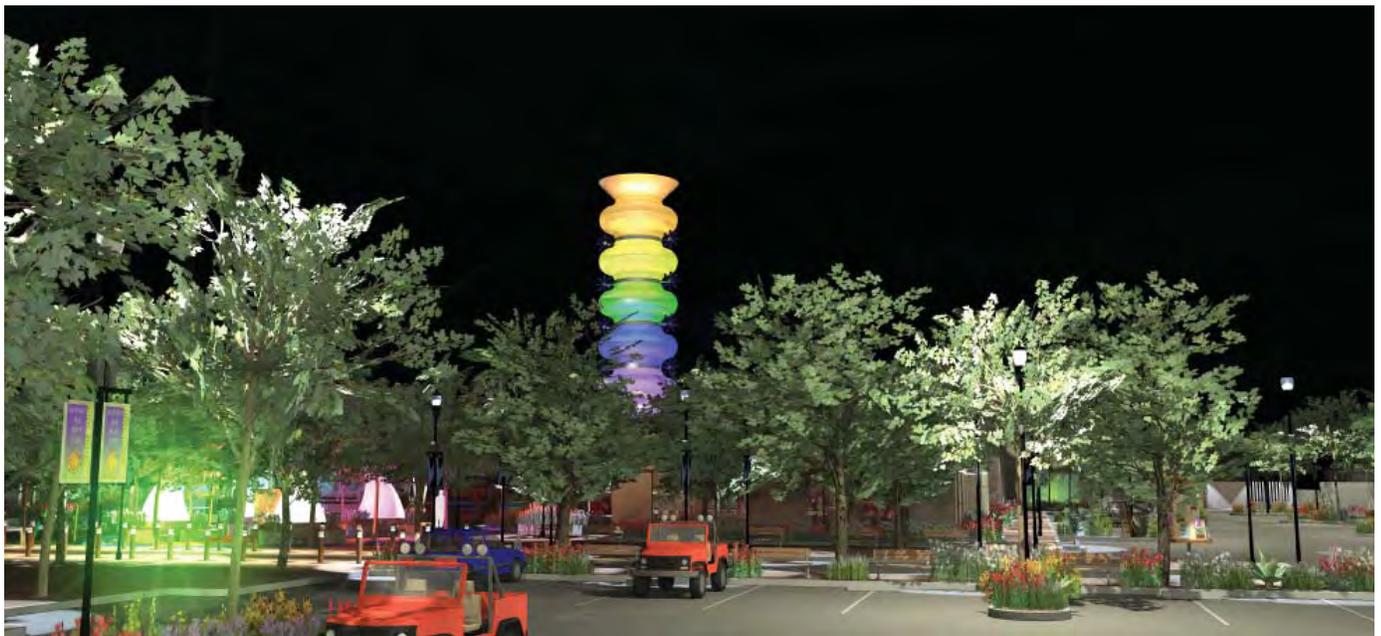
**North elevation and View North from South Parking Area.**

The one-story retail spaces serves as a transition between the School Annex Building and the proposed two-story commercial buildings near Jefferson Street.

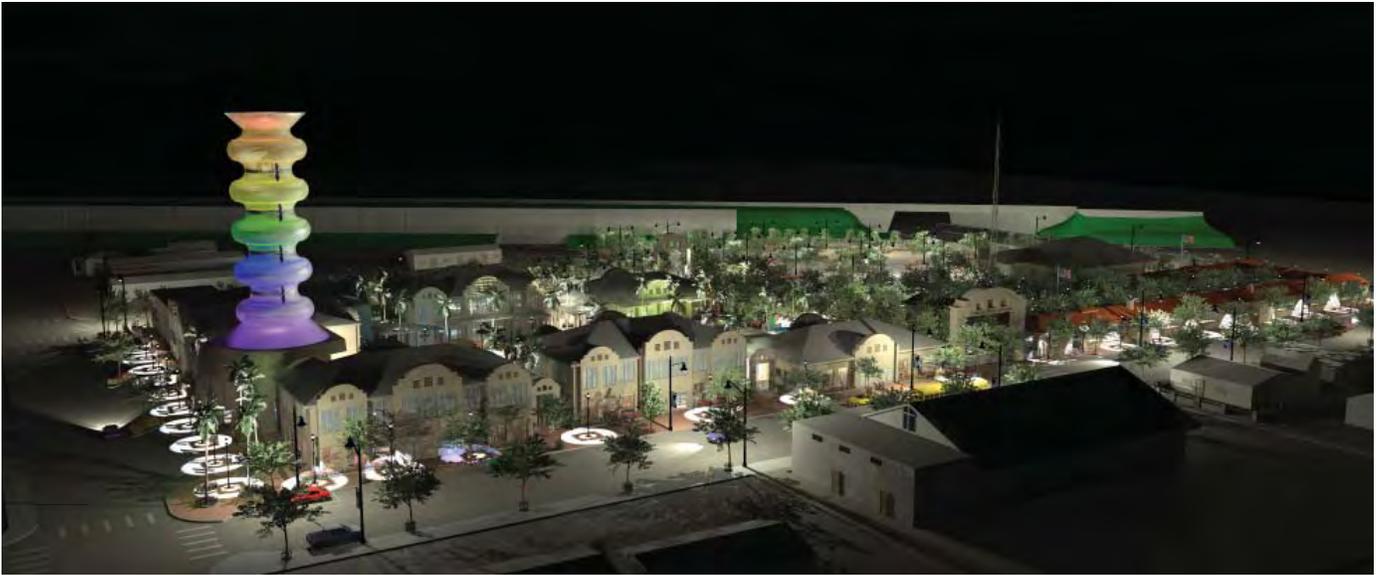
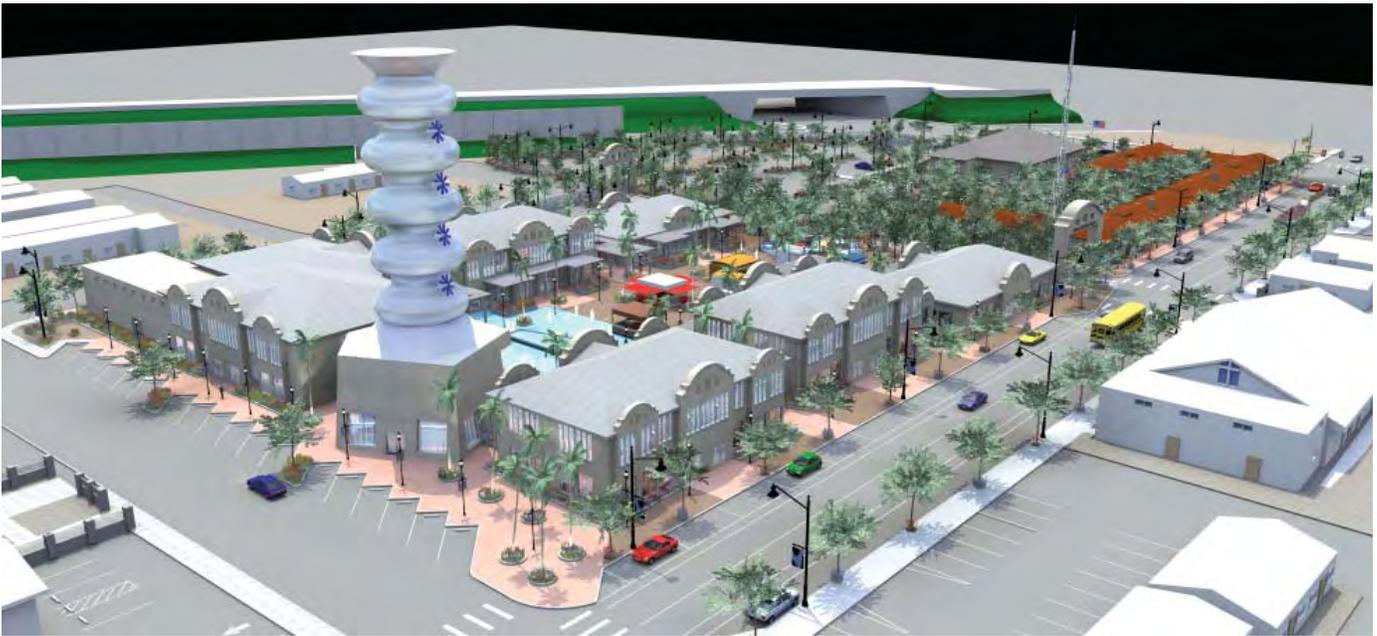
**Northwest Corner**

The gateway arches serve as a focal point for entry to the site from D Street and C Street. These majestic structures will be clearly visible from many locations in the West Las Vegas area and from US-15 and US-95.

The D Street corridor will be the entry point to West Las Vegas. The design calls for pavers or color concrete accent sidewalks. Pedestrian scale streetlights with decorative banners will line the street providing a Main Street feeling and provide pedestrian scale lighting that will enhance a nightly stroll. During the day the walk along D Street will be accented with landscaping that will complementary storefronts and the streetscape.

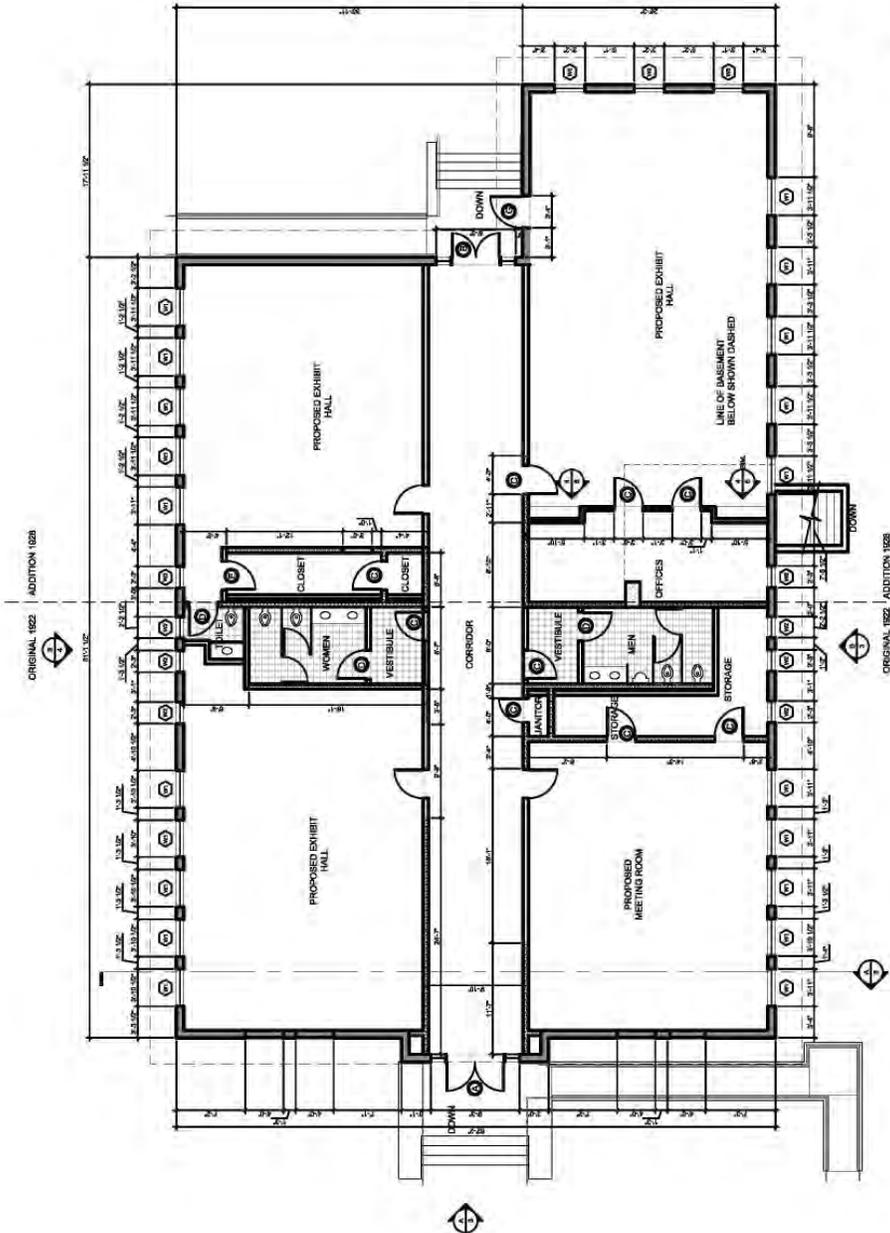
**WESTSIDE SCHOOL  
 FIRST FLOOR PLAN**  
 REFERENCE NORTH  
 SCALE: 3/16" = 1'-0"

- KEY NOTES**
- 1 EXTERIOR PLASTER
  - 2 STANDING BEAM METAL ROOFING
  - 3 BRICK CHIMNEY
  - 4 WOOD LOWER ATTIC VENT
  - 5 EXTERIOR PLASTER CAP
  - 6 METAL SECURITY GRILLE
  - 7 HISTORIC WOOD TRANSOM AND SIDELIGHTS
  - 8 NON HISTORIC WOOD DOOR
  - 9 NON HISTORIC WOOD SIGNAGE
  - 10 METAL DUTTER AND DOWNSPOUT
  - 11 WOOD RAFTER TAILS
  - 12 RECESSED PLASTER PANELS
  - 13 PLASTER TRIM
  - 14 CONCRETE LANDING AND STAIRS
  - 15 CONCRETE RAMP
  - 16 METAL HANDRAIL
  - 17 WOOD FRAME VENT WITH METAL SCREEN
  - 18 METAL BOLLARD
  - 19 WOOD BIEMMENT HATCH
  - 20 PLASTER SILL
  - 21 RECONSTRUCTED WOOD SASH IN HISTORIC WOOD WINDOW FRAME
  - 22 METAL PLAQUE
  - 23 HISTORIC WOOD SASH IN HISTORIC WOOD WINDOW FRAME

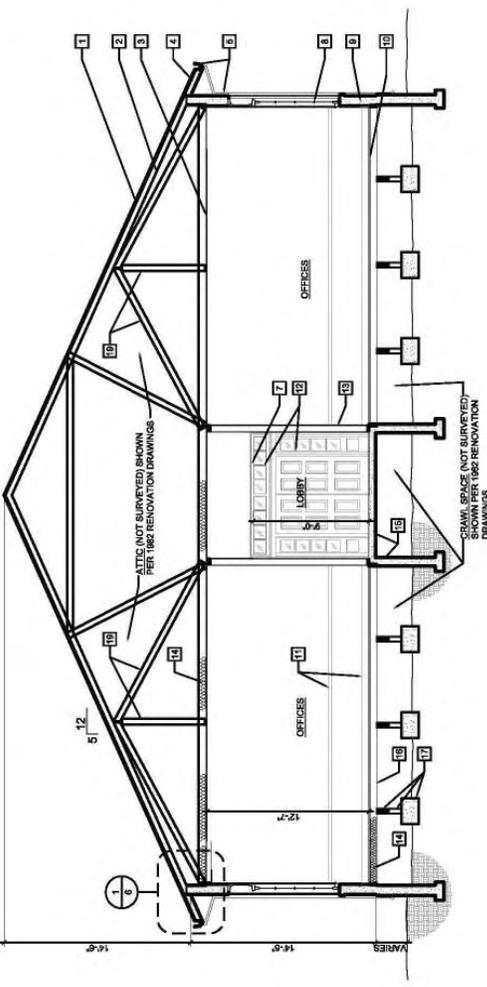
**A WESTSIDE SCHOOL SECTION**  
 SCALE: 1/4" = 1'-0"

- KEY NOTES**
- 1 STANDING SEAM METAL ROOF
  - 2 WOOD FRAMING
  - 3 HISTORIC PLASTER CEILING
  - 4 1/2" X 8" RAFTER TAILS @ 2' O.C.
  - 5 METAL GUTTER AND DOWNSPOUT
  - 6 WOOD FRAMED GYPSUM BOARD SOFFIT
  - 7 SUSPENDED ACOUSTIC TILE CEILING
  - 8 RECONSTRUCTED WOOD SASH IN HISTORIC WOOD WINDOW FRAME
  - 9 HISTORIC CONCRETE WALL
  - 10 HISTORIC 1 X 8 WOOD FLOOR DECK
  - 11 WOOD BASE BOARD AND CHAIR RAIL
  - 12 HISTORIC WOOD TRANSOM AND SIDELIGHTS
  - 13 HISTORIC 2X WOOD FRAMED WALLS
  - 14 INSULATION
  - 15 HISTORIC CONCRETE STEM WALL AND FLOOR
  - 16 HISTORIC WOOD FLOOR JOISTS
  - 17 HANGAR FLOORING AND WOOD POST
  - 18 4" HIGH PONY WALL
  - 19 WOOD TRUSSES ADDED TO EXISTING FRAMING

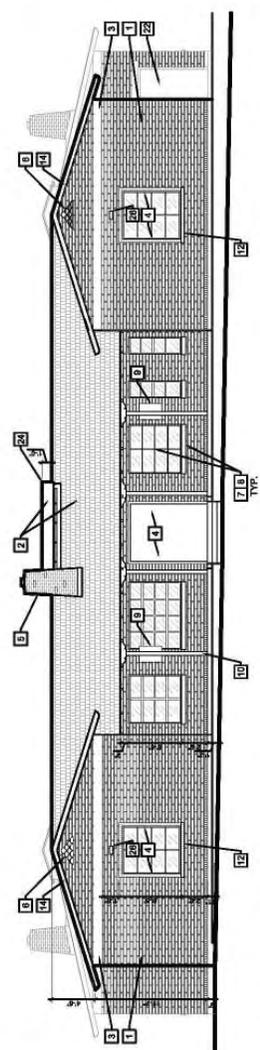
**A** SOUTH ELEVATION  
 SCALE: 3/8" = 1'-0"

- KEY NOTES**
- 1 BRICK MASONRY
  - 2 COMPOSITION SHINGLES
  - 3 CONCRETE HEADER
  - 4 ART PANEL
  - 5 BRICK CHIMNEY
  - 6 CLAY TILE FLASHING (SEE DETAIL 10 ON SHEET 18)
  - 7 MASONRY INFILL
  - 8 CONCRETE SILL (SEE DETAIL 4 ON SHEET 16)
  - 9 METAL PLAQUE
  - 10 METAL POST
  - 11 CONCRETE STAIRS
  - 12 BRICK SILL
  - 13 WOOD RAFTER TAILS
  - 14 WOOD FASCIA BOARD
  - 15 CONCRETE FOUNDATION
  - 16 WOOD POST AND TRUSS
  - 17 AIR CONDITION UNIT
  - 18 SHEET METAL ATTIC VENT
  - 19 STEEL SECURITY DOOR
  - 20 WINDOW SECURITY GRILLE
  - 21 HISTORIC STEEL WINDOW
  - 22 HOLLOW METAL FRAME STEEL DOOR
  - 23 METAL FRAME WINDOW
  - 24 GABLE RIDGE VENTILATOR
  - 25 WOOD CLADDING
  - 26 LIGHT FIXTURE
  - 27 LOWERED VEHT
  - 28 DECORATIVE CERAMIC TILE, SEE DETAIL 7 ON SHEET 15.

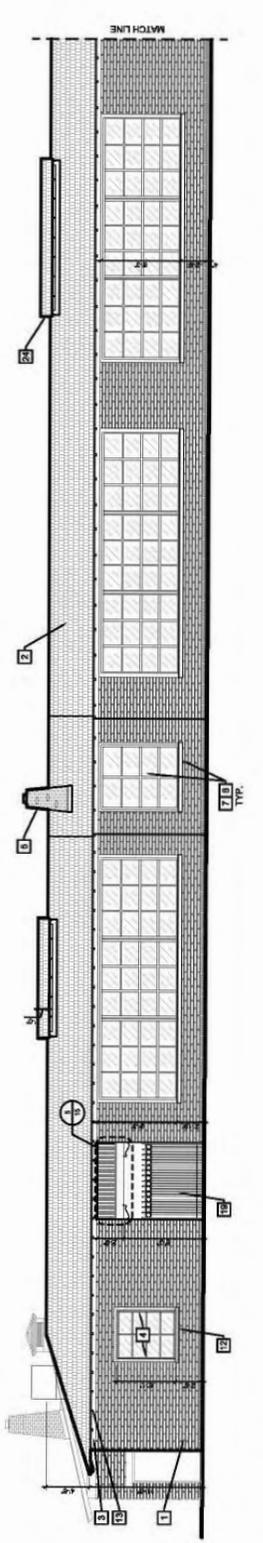
**A** WEST EXTERIOR ELEVATION  
 SCALE 1/4" = 1'-0"

- 1 BRICK MASONRY
- 2 COMPOSITION SHINGLES
- 3 CONCRETE HEADER
- 4 ART PANEL
- 5 BRICK CHIMNEY
- 6 CLAY TILE ATTIC VENT. SEE DETAIL 6 ON SHEET 15
- 7 MASONRY INFILL
- 8 CONCRETE SILL. SEE DETAIL 4 ON SHEET 15
- 9 METAL FLASHING
- 10 METAL POST
- 11 CONCRETE STAIRS
- 12 BRICK SILL
- 13 WOOD RAFTER TAILS
- 14 WOOD FASCIA BOARD
- 15 CONCRETE FOUNDATION
- 16 WOOD POST AND TIEBOLTS
- 17 AIR CONDITION UNIT
- 18 SHEET METALLIC VENT
- 19 STEEL SECURITY DOOR
- 20 WINDOW SECURITY GRILLE
- 21 HISTORIC STEEL WINDOW
- 22 HOLLOW METAL FRAME STEEL DOOR
- 23 METAL FRAME WINDOW
- 24 GABLED RIDGE VENTILATOR
- 25 WOOD CLADDING
- 26 LIGHT FIXTURE
- 27 LOUVERED VENT
- 28 RECONSTRUCTIVE CELESTINE TILE. SEE DETAIL 7 ON SHEET 15.
